Technical Report 05-07

*Utilizing a Hot Applied Snowmobile Crossing
Mat to Eliminate HMA Abrasion*

Construction and First Interim Report, August, 2007

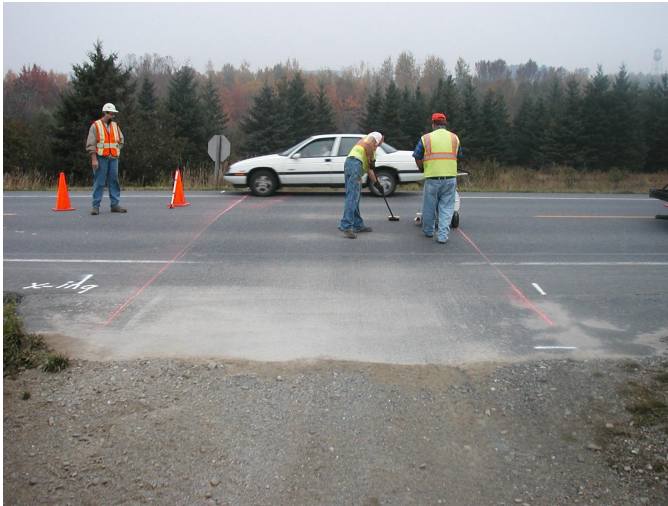
Photo 1. Cleaning Right Half of Crossing.

The first snowmobile crossing resurfaced was in Presque Isle on State Route 167. This is a two lane road with 4 foot paved shoulders. The shoulder was extended an additional 4 feet on either side of the snowmobile crossing for a total width of 38 feet. Traffic was maintained in one lane during construction. The area was swept and dust was blown off the surface as displayed in Photo 1.

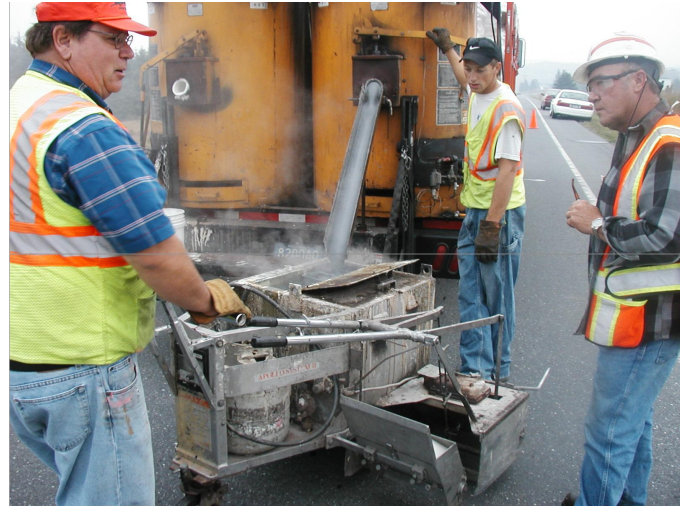
Photo 2. Filling the Application Cart.

Cleanosol E4190-35 is a solid material that needs to be heated prior to application. Application temperature is dependent on pavement temperature; higher temps are for cold pavements. A boiler is positioned on the back of the transport truck and is used to heat and distribute the material to the application cart. A chute is used to fill the application cart which has a capacity of 2 cubic feet as seen in Photo 2. The material is placed in a three layer process. The application cart places the material in 12 inch strips to a depth of 0.12 inch. Each pass is overlapped by 1 inch. Silica sand is distributed on the surface of each pass by way of a bucket attached to the back of the application cart as displayed in Photo 3. The sand adds texture to the mat and aids in the bonding between layers.

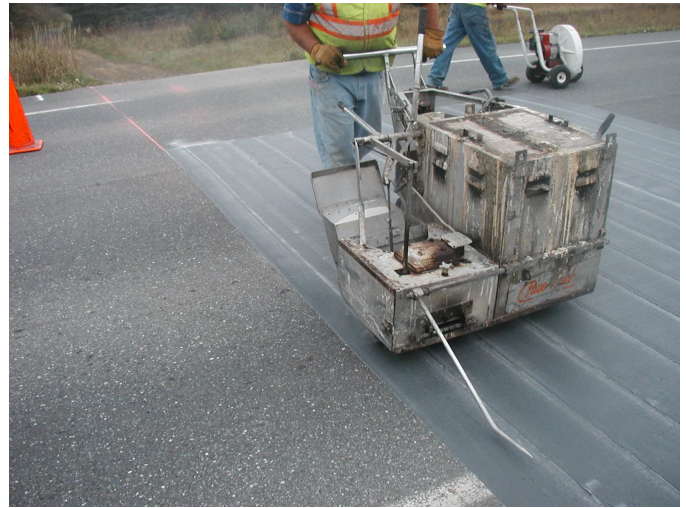
Photo 4. Starter Pass for Second Lift (6 inch offset).

The procedure begins with starting the first layer three feet left of centerline and proceeding right to the right edge of pavement. It took 14 passes to cover the full width of the snowmobile crossing. Curing time for each pass is 2 – 3 minutes. The second layer begins \pm 3 inches inside the first layer at the butt joint and at an offset of 6 inches from the leading edge of the first layer to smooth the transition from pavement to Cleanosol, see Photo 4. The third layer begins \pm 3 inches from the underlying layer at the butt joint and is also offset 6 inches from the leading edge of the second layer. Photo 5 displays the centerline butt joint. Traffic was allowed on the mat after 15 minutes.

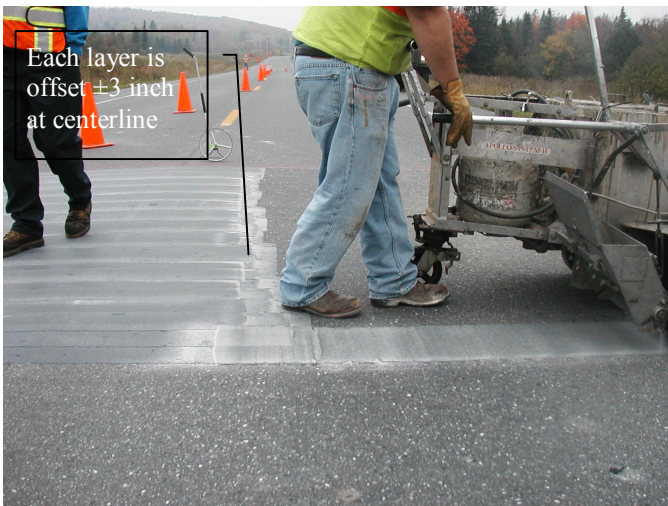
Photo 5. First Pass on Left Side of Crossing

Photo 5 shows an overlap of all three layers for the first pass of the first layer for the second half of the crossing. This is the only pass that was placed in this fashion; the remaining strips had an overlap of 1 inch on the corresponding layer as shown in Photo 6. It appears that every pass has an overlap of 1 inch at the butt and longitudinal edge except for the beginning of each layer which has an offset of \pm 3 inches from the butt joint and 6 inches from the leading edge.

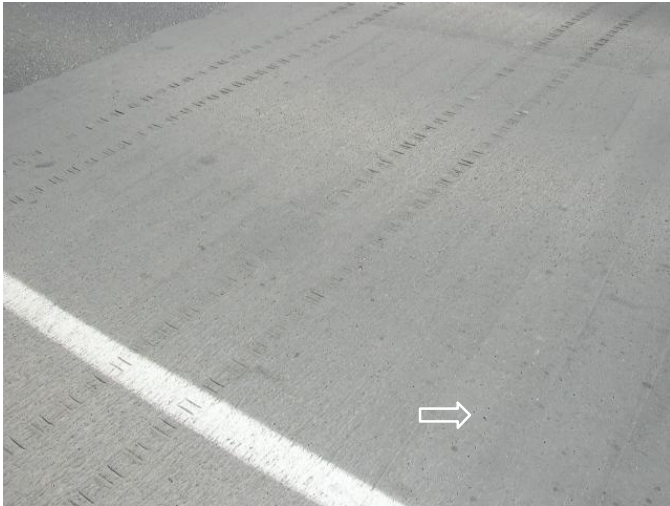
Photo 7 Presque Isle Crossing Carbide Stud Pitting

Carbide studs on snowmobile tracks have pitted the mat as displayed in Photo 7. The pits are 0.125 inch wide and range in depth from 0.125 to 0.187 inch. Pitting is more prevalent on the roadway shoulders and at each quarter point and centerline. It appears that traffic has kneaded the mat and closed most of the holes in each wheel path.

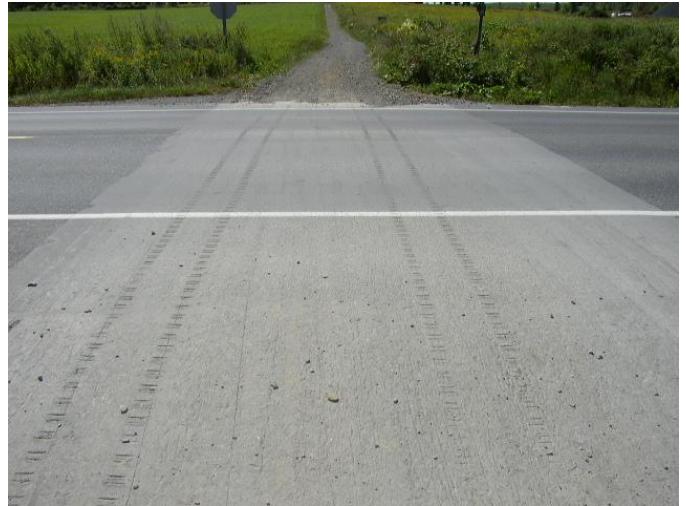
Photo 8 Presque Isle Crossing Equipment Marks

Photo 8 displays a mark across the mat that was made from a track mounted heavy piece of equipment. This area is mainly farmland and many farmers use the snowmobile trails to transport farm equipment to the fields. The track mark penetrated the mat to a depth of 0.125 inch.

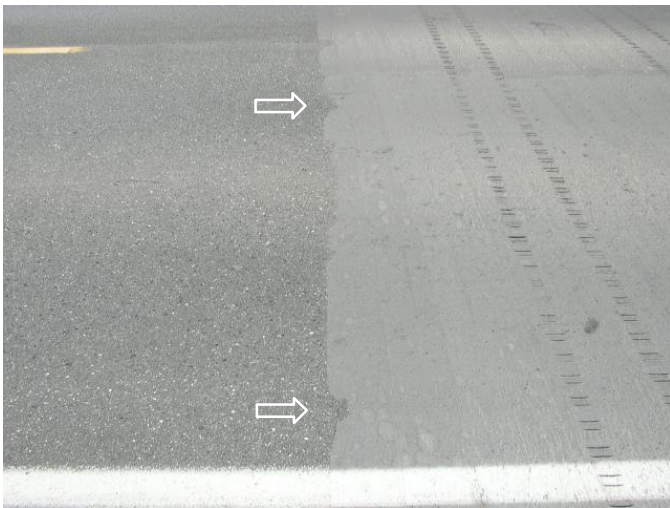
Photo 9 West Bound Leading Edge Plow Wear

The leading edge of the mat in both directions has been worn from winter plowing mainly at centerline and the quarter points. Photo 9 displays the west bound leading edge and Photo 10 the east bound leading edge. Between 1 and 4 inches of mat is worn away. The trailing edge is intact. Traffic has worn the wheel path leading and trailing edge very smooth and even with the pavement.

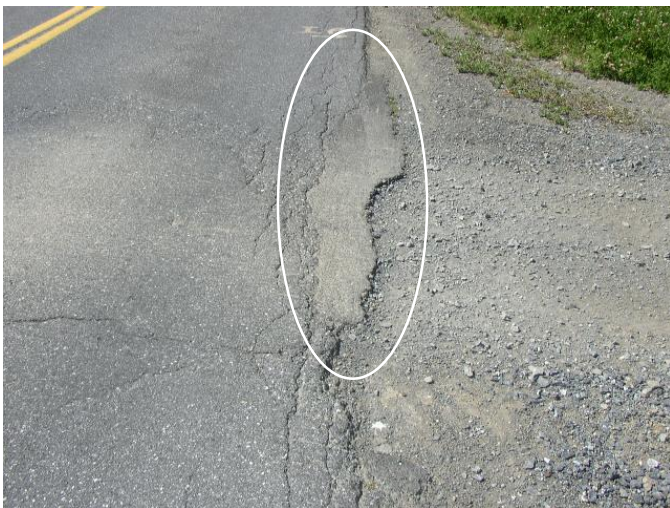
Photo 11 Control Crossing Pavement Edge Patch

The crossing at State Street has multiple patches in the shoulders on both sides of the road as shown in Photo 11. The majority of shoulder pavement damage is caused from snowmobiles crossing the roadway from a standstill after waiting for traffic to clear. The carbide spikes tear the leading edge of the pavement until it is raveled into the travel way. At that point maintenance crews patch the shoulder to reduce the advancement of pavement ravel.

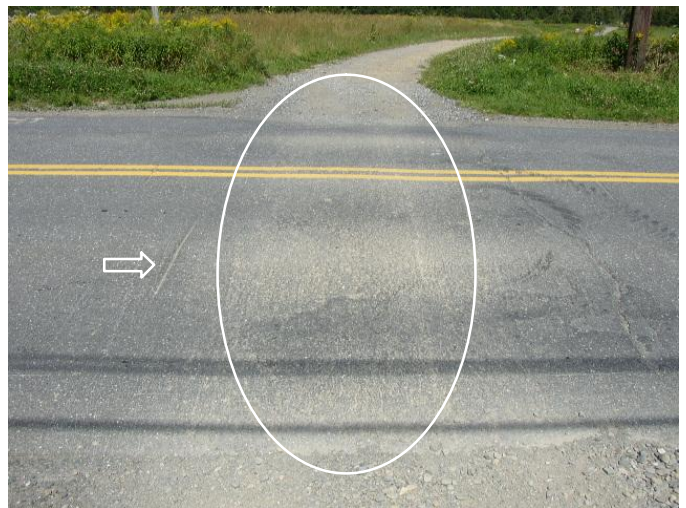
Photo 12 Control Crossing Rutting and Cuts

Snowmobiles have worn a rut across the roadway that is 0.25 inches deep. There are four cuts in the pavement at centerline and each quarter point that are 0.187 inches deep and range in length from 1 to 3 feet. It's difficult to determine if snowmobile carbide blades or farm machinery caused the cutting. Photo 12 displays the snowmobile rutting and cuts.

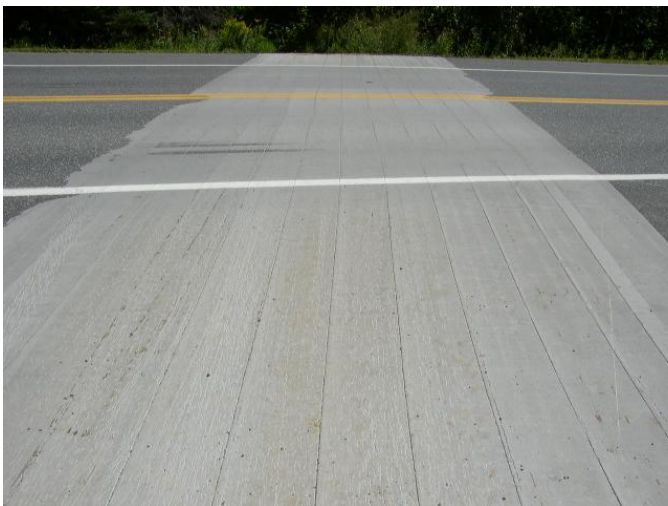
Photo 13 Mars Hill Crossing Shoulder Track Wear

Snowmobile track wear and pitting in the shoulder areas are much more noticeable at this crossing than the Presque Isle crossing as revealed in Photo 13. The crossing has more snowmobile and vehicular traffic than the Presque Isle crossing. Snowmobile users may have fewer opportunities to cross the roadway and may be crossing at greater velocities from a stand still which may be increasing the amount of shoulder track wear.

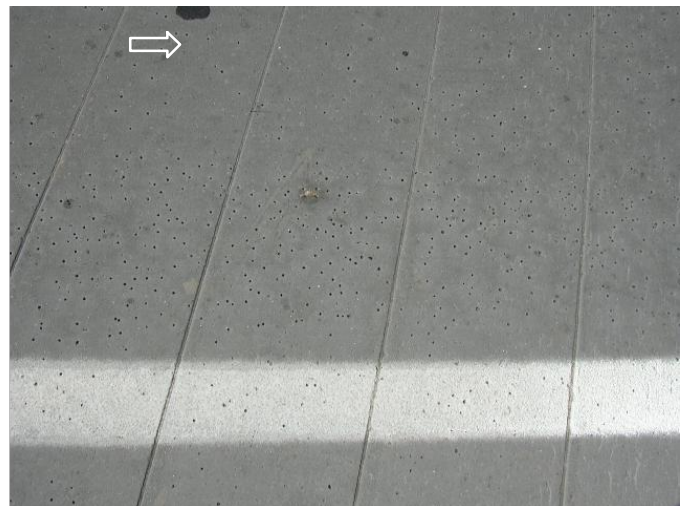
Photo 14 Mars Hill Crossing Spike Marks

carbide spikes to penetrate the mat while the shoulders may be cold enough to reduce penetration. Spike and track marks in each wheel path are less noticeable; it appears that traffic kneads the mat during summer weather making the snowmobile marks less visible as shown in Photo 14 (arrow is in the wheel path).

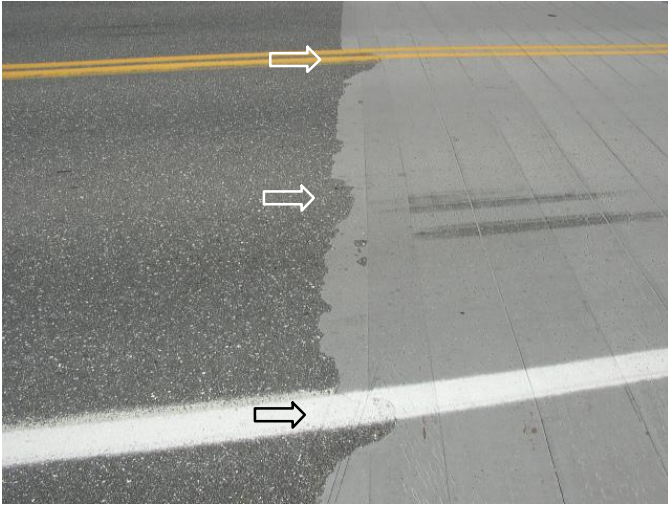
Photo 15 Mars Hill Crossing Plow Wear

The leading edge of the mat has plow wear at the shoulder joint, quarter point, and centerline as displayed in Photo 15. Plow wear is as much as 6 inches into the mat.

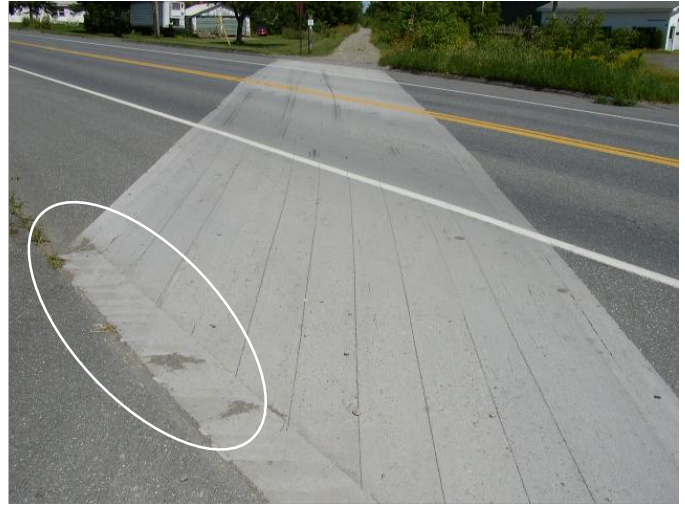
Photo 16 Bridgewater Crossing Additional Strip

This crossing is skewed at a 45 degree angle and has the greatest volume of snowmobile and vehicular traffic than the other experimental and control crossings. This crossing also has an additional strip of material at the each end of the mat to square up the mat with the pavement edge as seen in Photo 16. The amount of snowmobile track wear and pitting is slightly greater than the Mars Hill crossing. Many spike holes can be seen on each end of the mat as shown in Photo 17. The roadway portion of the mat shows less pitting than each end possibly due to traffic smoothing out the marks.

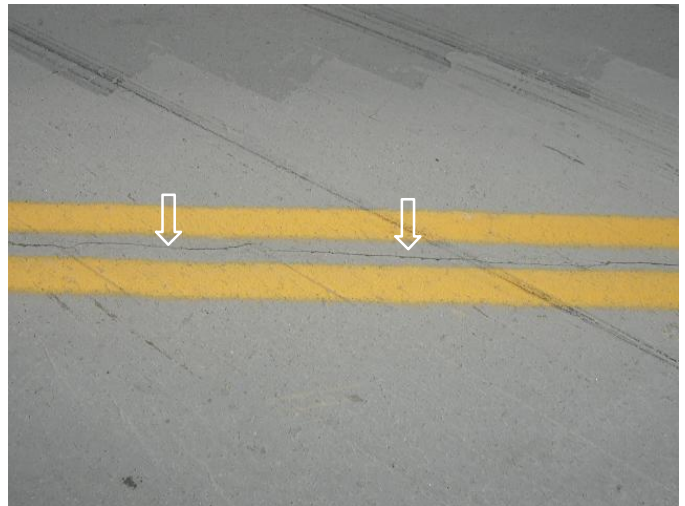
Photo 18 Bridgewater Crossing Centerline Crack

US Route 1 had a cracked centerline joint prior to placing Cleanosol and the crack has reflected through the mat as seen in Photo 18. The crack has not visibly affected the mat.

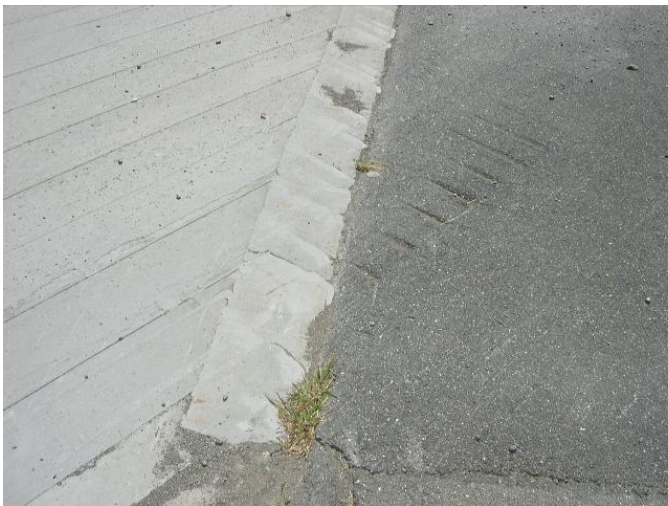
Photo 19 Bridgewater Crossing Track Marks

A local farmer used the snowmobile crossing to transport a heavy piece of farm equipment. The farm equipment left ¼ inch deep marks on the paved shoulder but no visible marks on the Cleanosol mat as displayed in Photo 19. It's possible that the operator had to wait for traffic to clear prior to crossing and while waiting the track may have sunk into the hot pavement. When the equipment did cross, the track may not have had enough time to apply enough pressure on the mat to leave a mark. The same could be said about the decreased number of snowmobile spike marks in the roadway portion of the mat.
